HINDS MANAGED AQUIFER RECHARGE PILOT TRIAL

APPENDICES COMPILATION

Report Number: 1538632-7410-024-Appendices

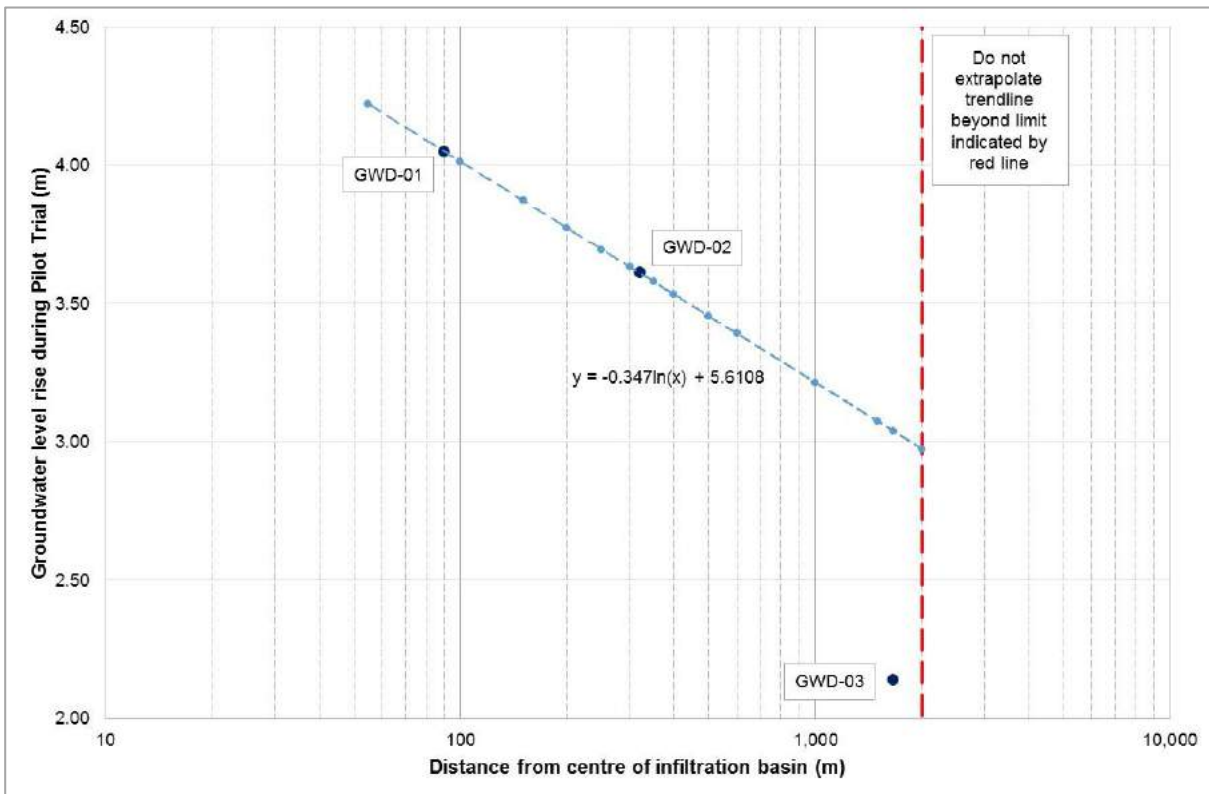
Figure G28: Extent and magnitude of groundwater level rise in regional aquifer transect.

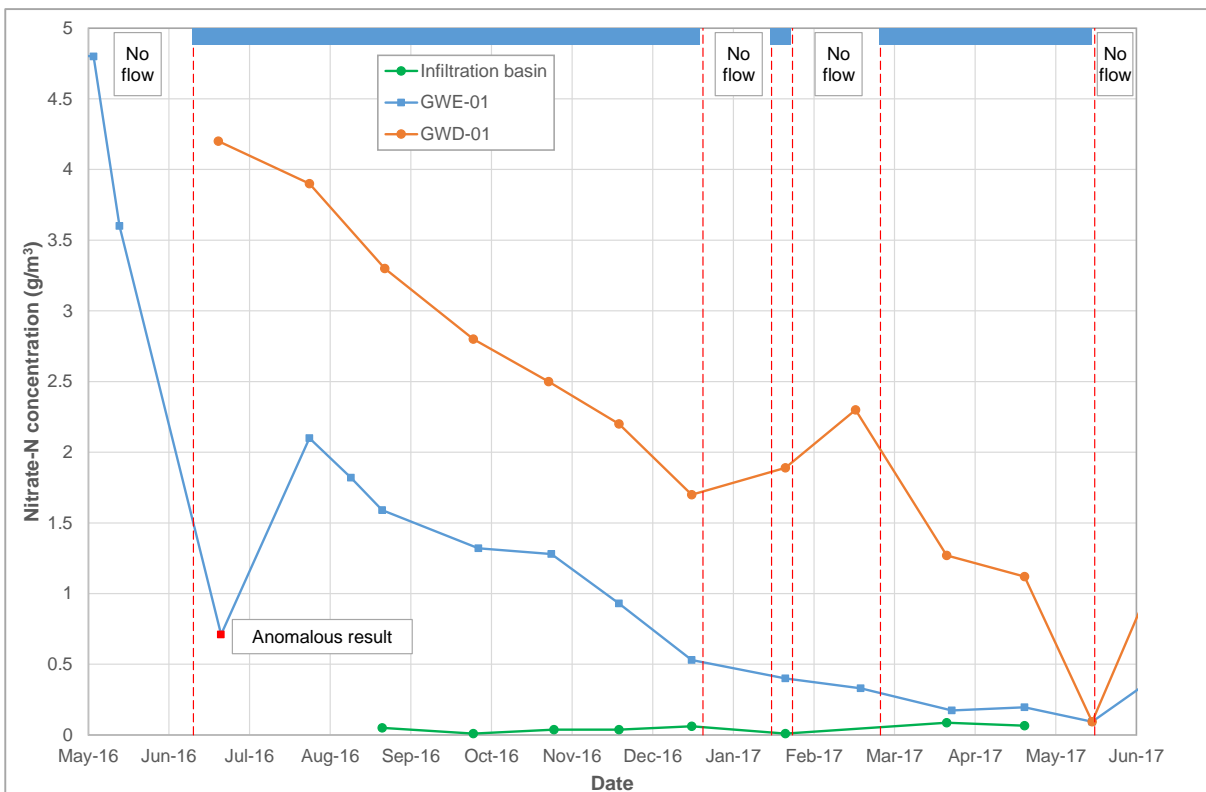
Figure H14: Nitrate-N concentrations in groundwater samples from beneath the Pilot Trial site during the trial.

Nitrate-N concentrations in the source water during the trial (Figure H2) have been substantially lower than those detected in the underlying groundwater, both perched and in the regional system. As a consequence, the initiation of artificial recharge through the floor of the infiltration basin resulted in measured nitrate-N concentrations in the underlying groundwater decreasing (Figure H14).

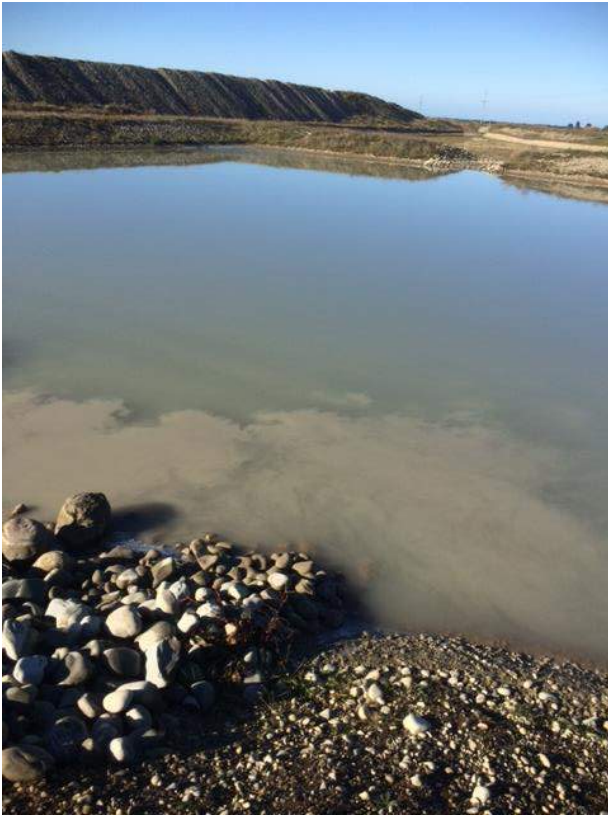
Figure I4: Sediment plume from inflow spillway to forebasin.

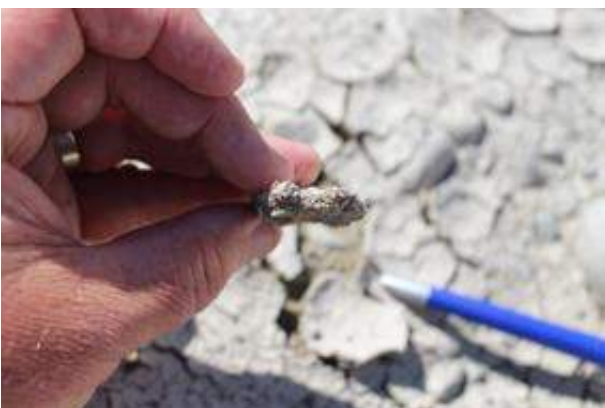
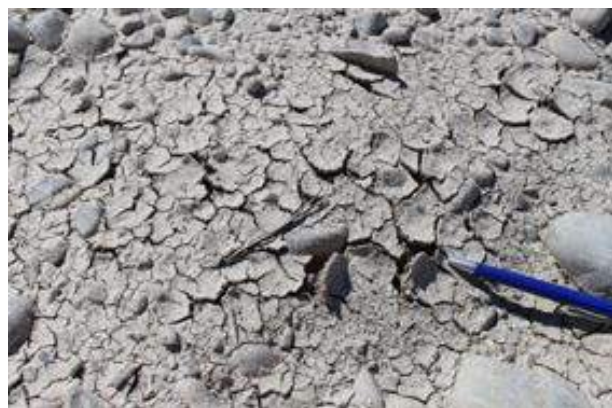
Algal growth was observed in both the main infiltration basin and the forebasin during the trial. Although samples of the settled material have not been sent to a laboratory for analysis, it is likely that it consists of a combination of clastic particles (sand, silt and clay) and organic material derived from the algal growth.

Figure I5: MAR basin clogging layer as seen in forebasin.

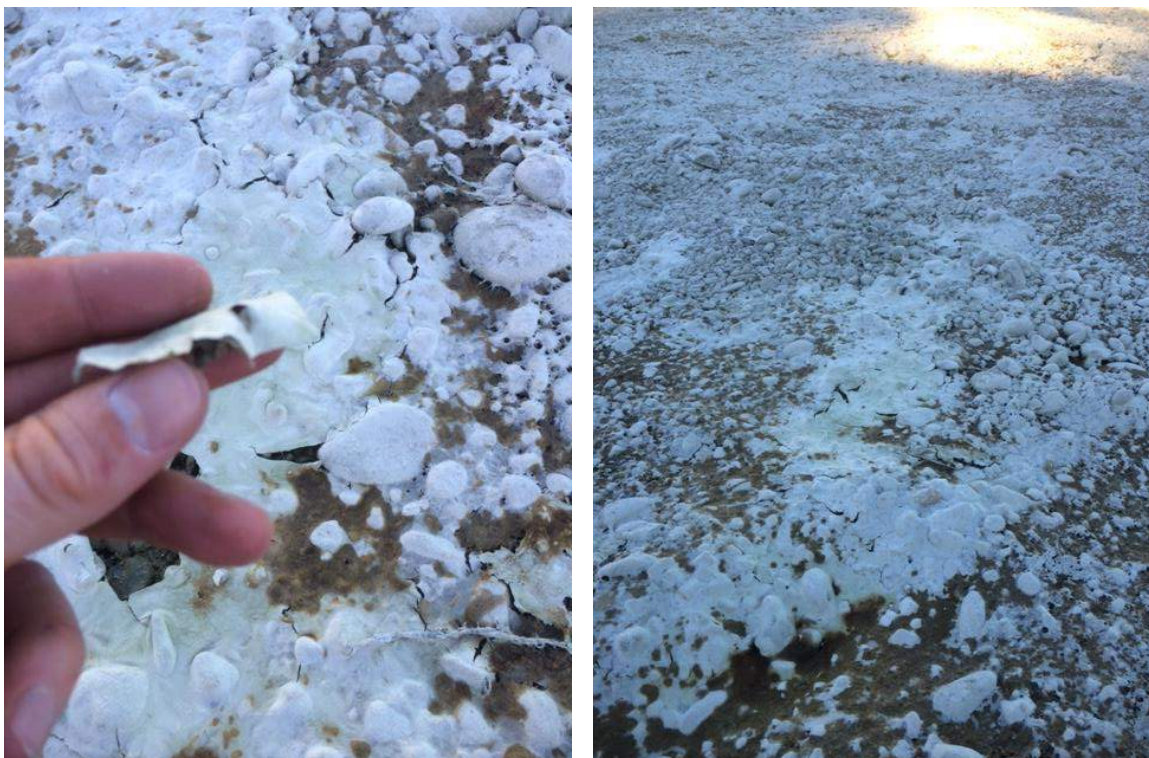
- Fine clastics (silt and clay) transported through from the forebasin.
- Soil eroded by run-off from the bunds surrounding the basin.
- Remnants from algal growth in the basin.

Figure I6: MAR basin clogging layer as seen in infiltration basin.

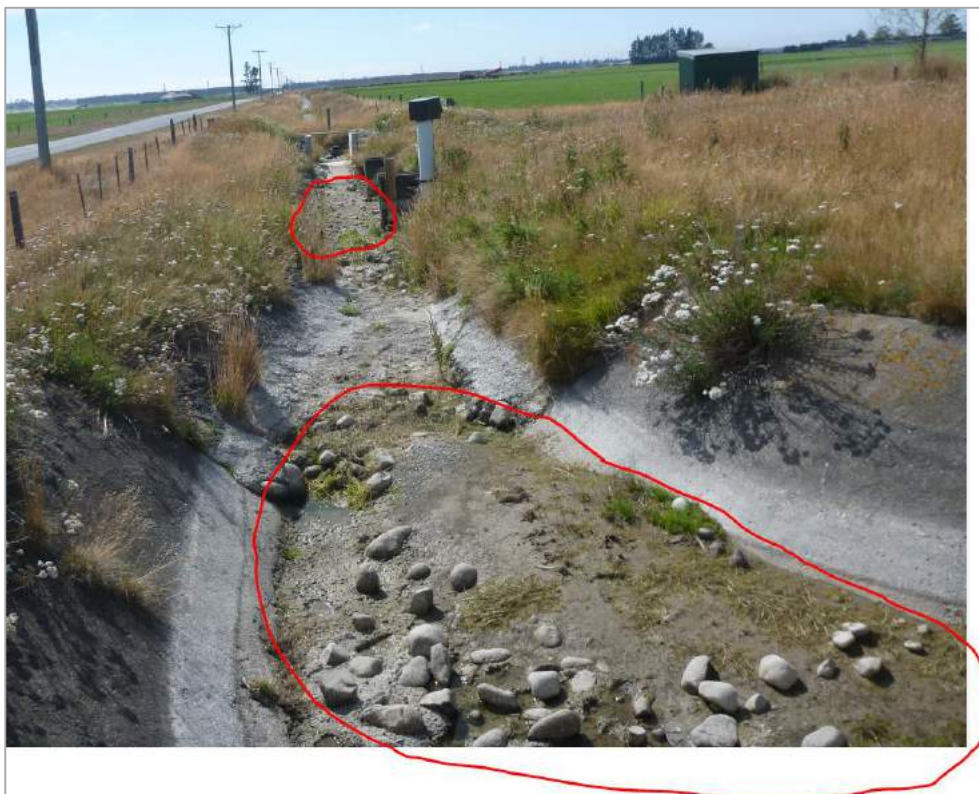
Figure L4: MAR race upstream from Flume 1 showing sediment deposited (red circles) during Year 1.
